Red Route Study
B4525 Crowfield to
Middleton Cheney

30th Sept 2012

1 Introduction

1.1 This Study has been prepared Northamptonshire County Council. Its key objective is to analyse the personal injury accidents on the B4525 from the roundabout at the junction with the A422 near Middleton Cheney to the village of Crowfield to reduce the frequency and severity of accidents by engineering methods.

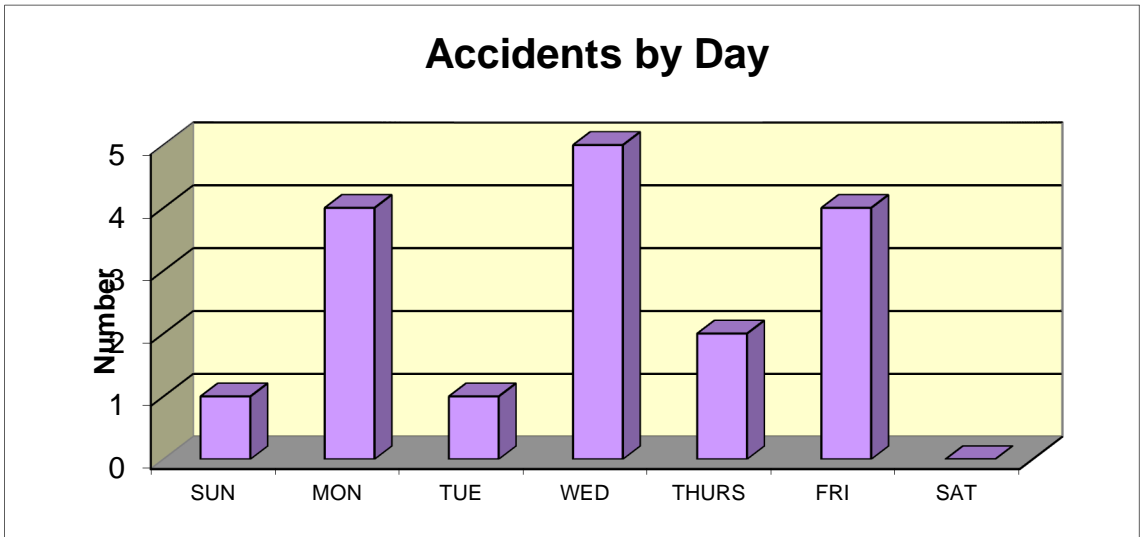
Graph 3/1

3.9.1 The following graphs (3/1, 3/2 and 3/3) show the distribution of accidents by month, day and time of day.

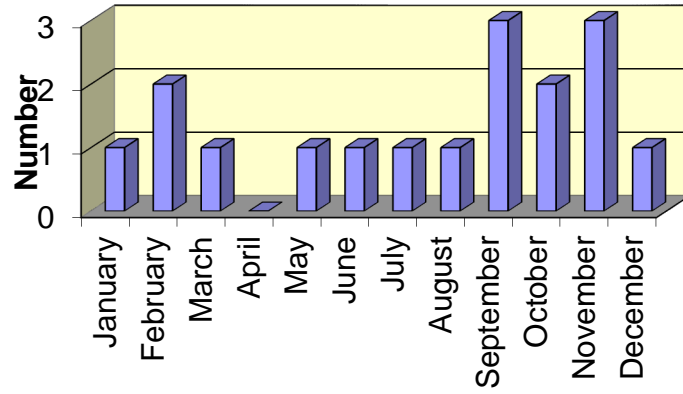
Graph 3/3

Accidents by Month
