## Red Route Study B4525 Crowfield to Middleton Cheney

1.1 This Study has been prepared Northamptonshire County Council. Its key objective is to analyse the personal injury accidents on the B4525 from the roundabout at the junction with the A422 near Middleton Cheney to the village of Crowfield to reduce the frequency and severity of accidents by engineering methods.

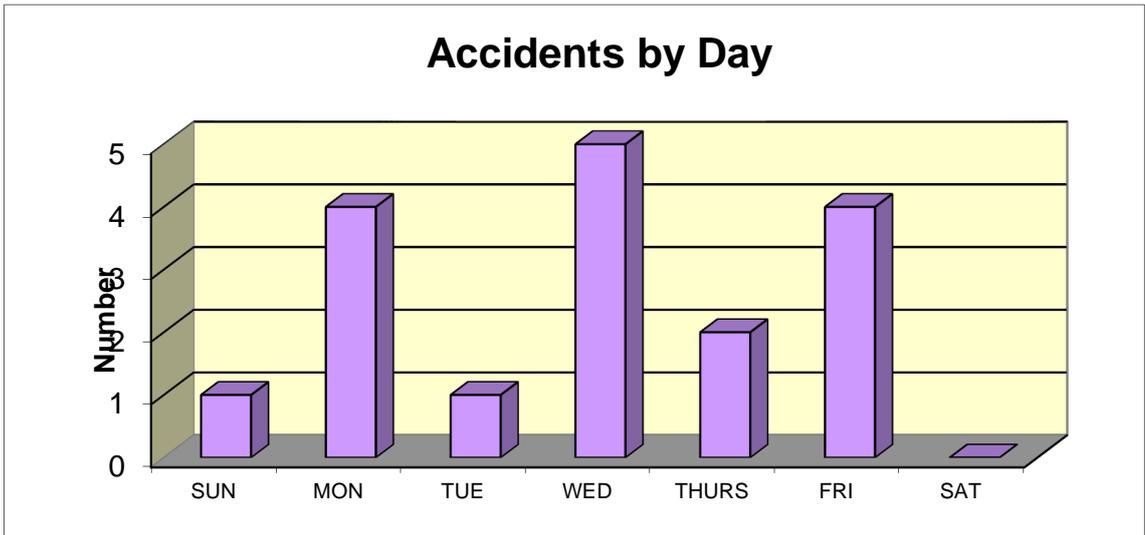
Graph 3/1

3.9.1 The following graphs (3/1, 3/2 and 3/3) show the distribution of accidents by month, day and time of day.

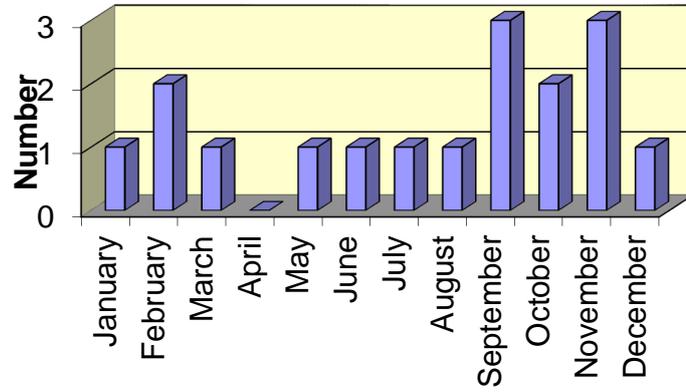
Graph 3/3

# Accidents by Month
